Manhole Inspection Summary

Manhole # S45E__038MH

Insp Date: **8/14/08 9:27 AM**

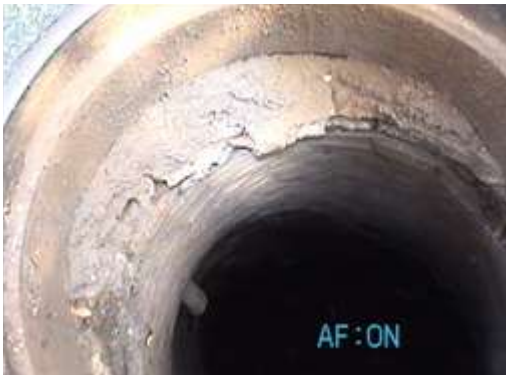
Defect 2

Condition: ☐ Sound ☐ Cracked ☐ Root Intrusion ☒ **Loose Brick** ☐ Deteriorated

Infiltration: ☐ None ☐ Joint ☐ Cracks ☒ **Mortar** ☐ Roots ☐ Wall

Loose brick

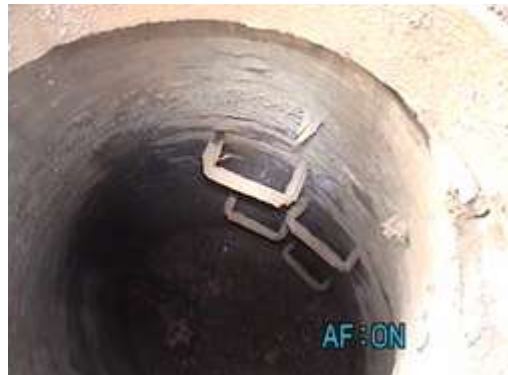
Defect 1

Infiltration: ☐ None ☐ Joint ☐ Cracks ☐ Mortar ☐ Roots ☒ **Wall**

Infiltration

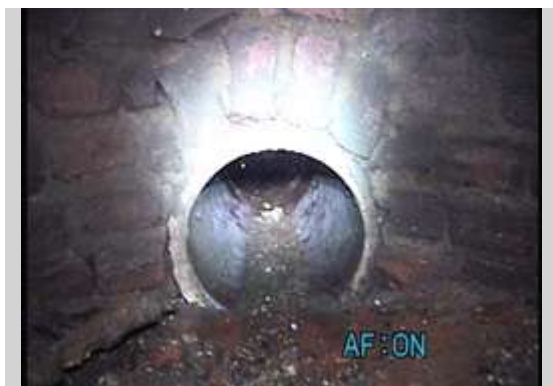
12 O'Clock Outflow

8 in. Circular Gravity Sewer
Pipe Out @ 12 O'Clock

Infiltration: **None** Pipe Seal Cond: **Sound**
